**PLATFORMER POOL FIRE
INCIDENT INVESTIGATION
JULY 19, 2018**

Final Report
October 16, 2018

Kern Oil & Refining Co.

Michael P. Broadribb

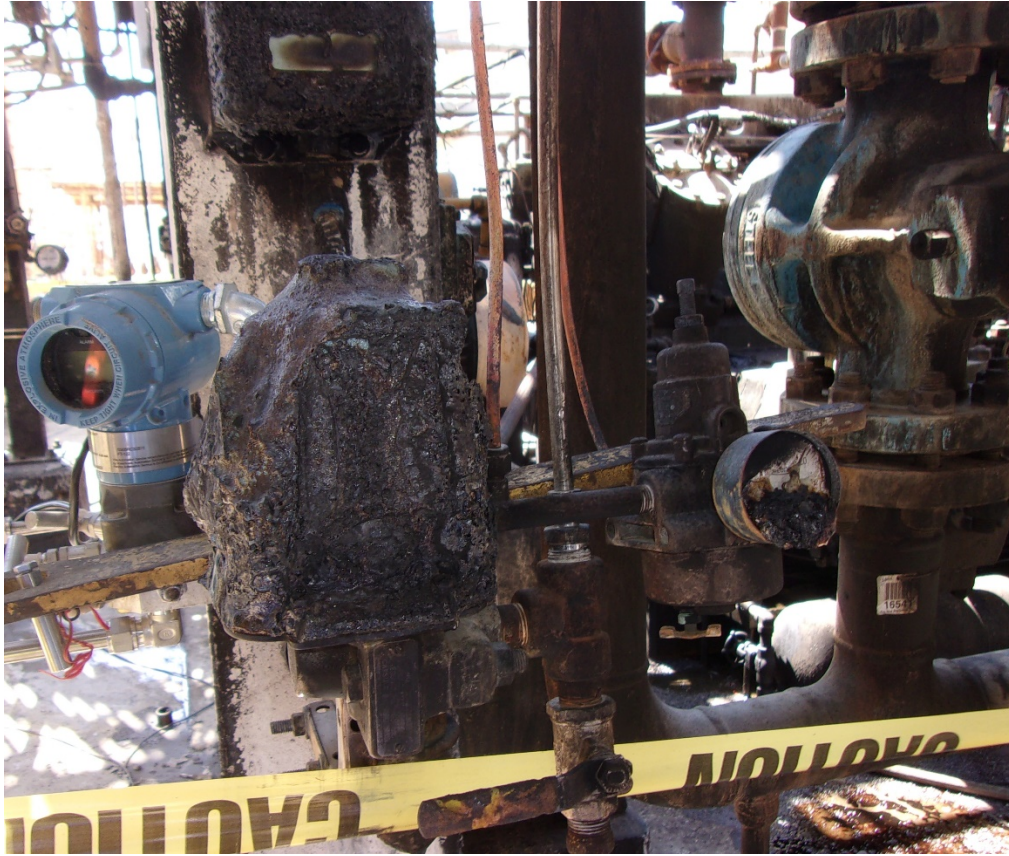
There were no injuries, but the fire resulted in damage to instrument and electrical systems, and caused the South Control Room to lose the DCS without serious upset to other process units. Figure 1 and Figure 2 illustrate some of the fire damage.

Figure 1. Damage to Instrumentation

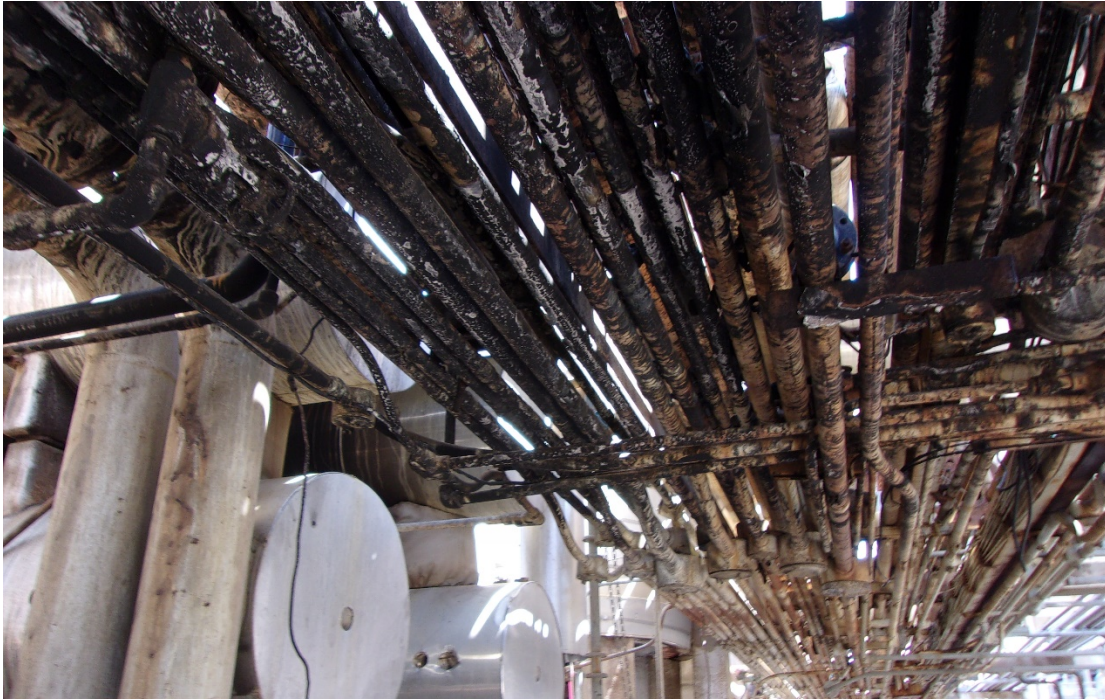
Figure 2. Damage to Overhead Piperack

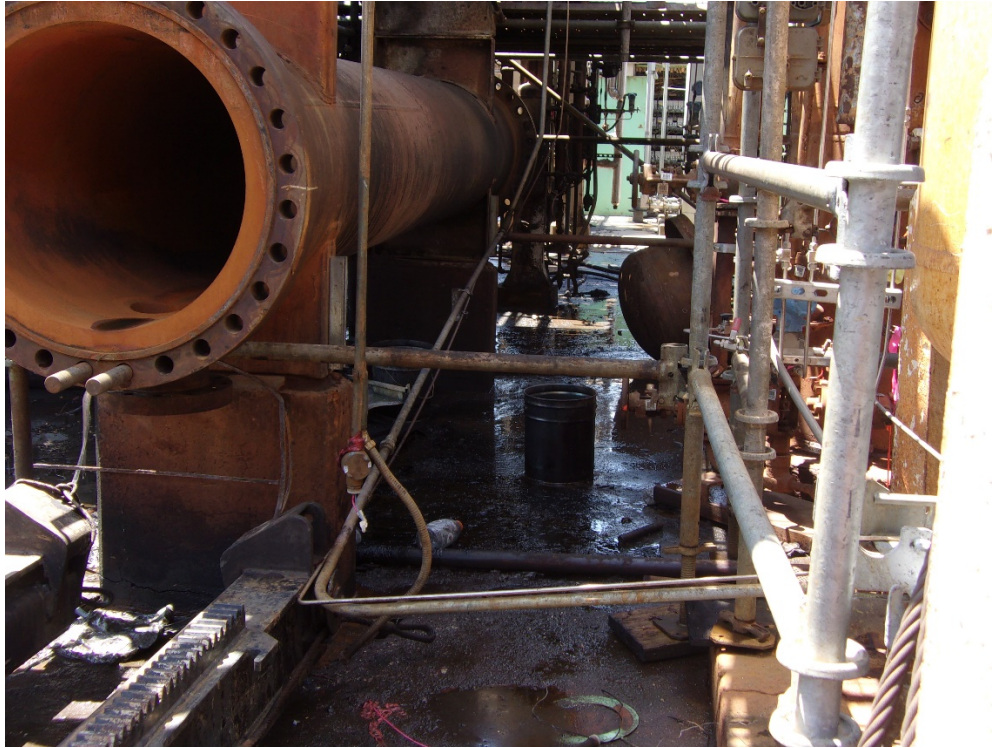
The conduit that was broken was corroded where the conduit passes underground through the concrete pad. This corrosion made the conduit susceptible to impact damage. In the 48 hours prior to the incident, there were multiple activities taking place within close proximity to the conduit. These activities included heavy equipment (two cranes and heat exchanger tube bundle puller), scaffolding erection, and heat exchanger head and piping removal. The damage to the conduit was not immediately reported to Operations, but it is highly likely that one or more of these activities were responsible for the damage. Figure 3 shows the heat exchanger tube bundle puller in front of the High Pressure Effluent Cooler Exchangers (3530.09 and 3530.10) with the broken conduit to the right. Note that the red safety tape has been removed. Figure 4 is a close up of the broken conduit after the fire when the wiring had been made safe.

Figure 3. Heat Exchanger Tube Bundle Puller beside Broken Conduit

The July 2018 Platformer turnaround involved multiple activities in the vicinity of conduit adjacent to the Platformer HP Effluent Coolers (3530-09 & 3530.10). At some stage prior to 3:00am on July 19th, the conduit (containing live wiring) was broken at ground level. The damage was not immediately reported to Operations. A contractor observed sparking from the conduit and informed operators in the Platformer control room at approximately 3:35am on July 19th. The broken conduit was observed leaning against the wheel of a heat exchanger bundle pulling device.

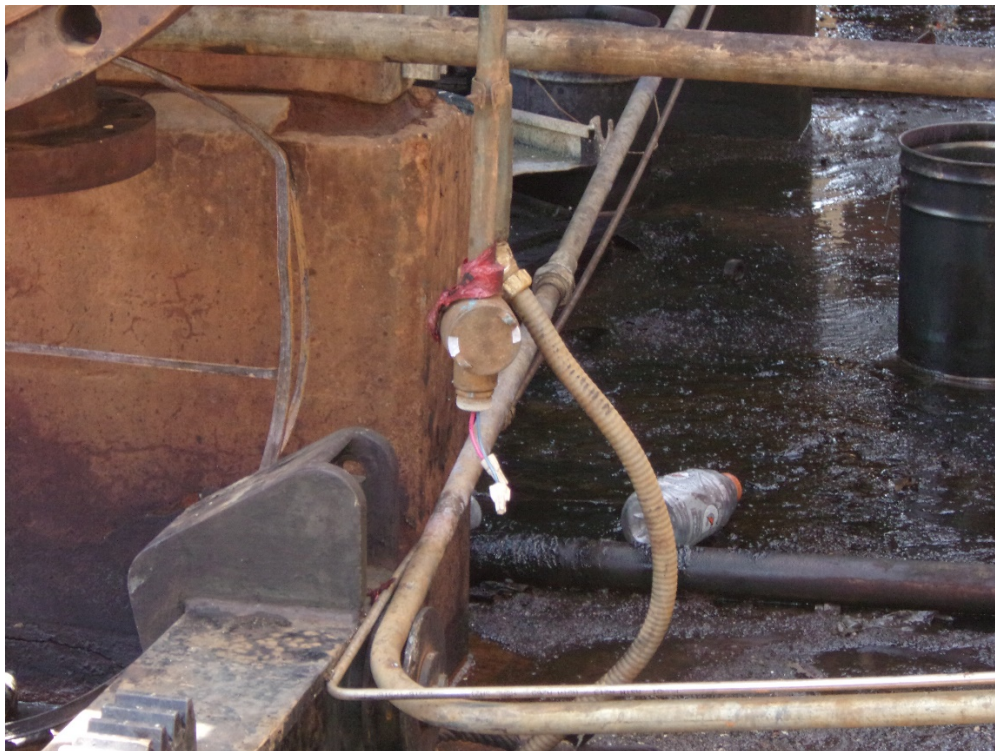
Figure 4. Broken Conduit with Wiring Protected after Fire

The Investigation Team also determined that the broken conduit was altered after the incident. The conduit was de-energized and a GUA conduit outlet box installed on the end of the conduit.

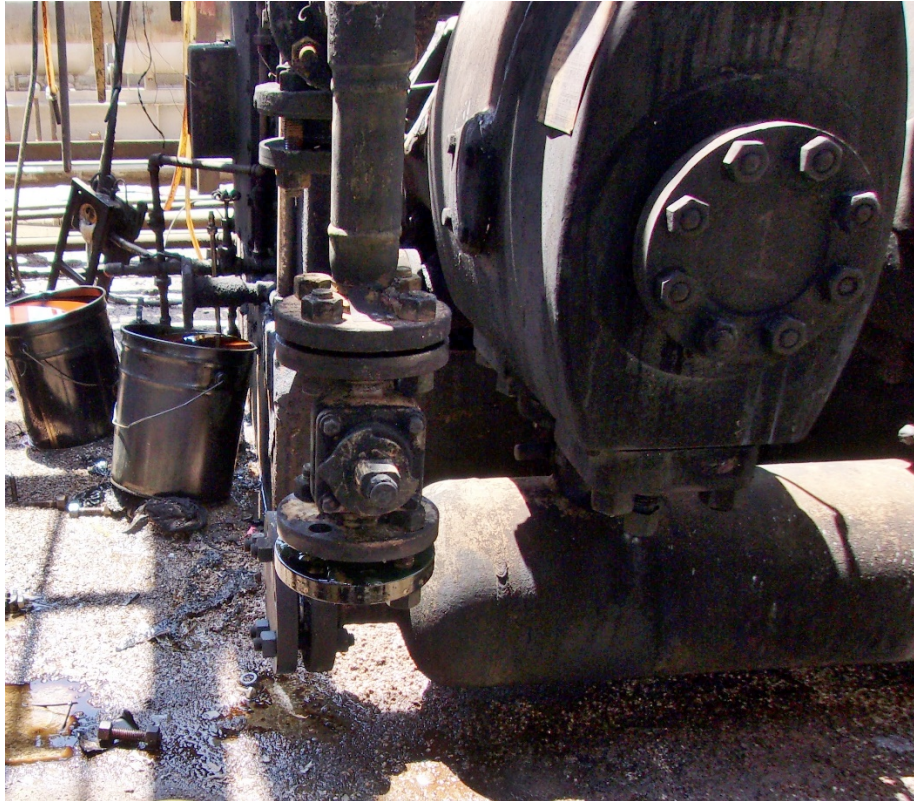
The Platformer flare header was drained from a 1 inch valve for several days prior to the incident using a closed system of flexible hoses to the sump at the north end of the unit. On July 19, 2018, in preparation for the proposed cold cutting of the flare header, a location closer to the cut was used. Residual liquid drained through a 3-inch valve by Compressor 3528.07 on to the ground, and a contractor used a water hose to flush the liquid towards a drain by the Platformer Control Room. Later a slug of liquid continued to drain to ground for several minutes and was the source of the main fire. Figure 5 shows the 3-inch drain valve with the loosened blank flange below.

Figure 5. Flare Header Drain Valve by Compressor 3528.07

Draining of light hydrocarbons to ground is not a preferred practice, and especially so on a day with high ambient temperature (ca. 100°F) that would evaporate a significant proportion of the liquid to produce a flammable vapor cloud. At the time of the incident, the refinery did not have a general safe work practice covering line and equipment breaking, although several operating procedures did address specific aspects for certain processes. The refinery issued a new line and equipment breaking procedure in August 2018 [ref. 7].

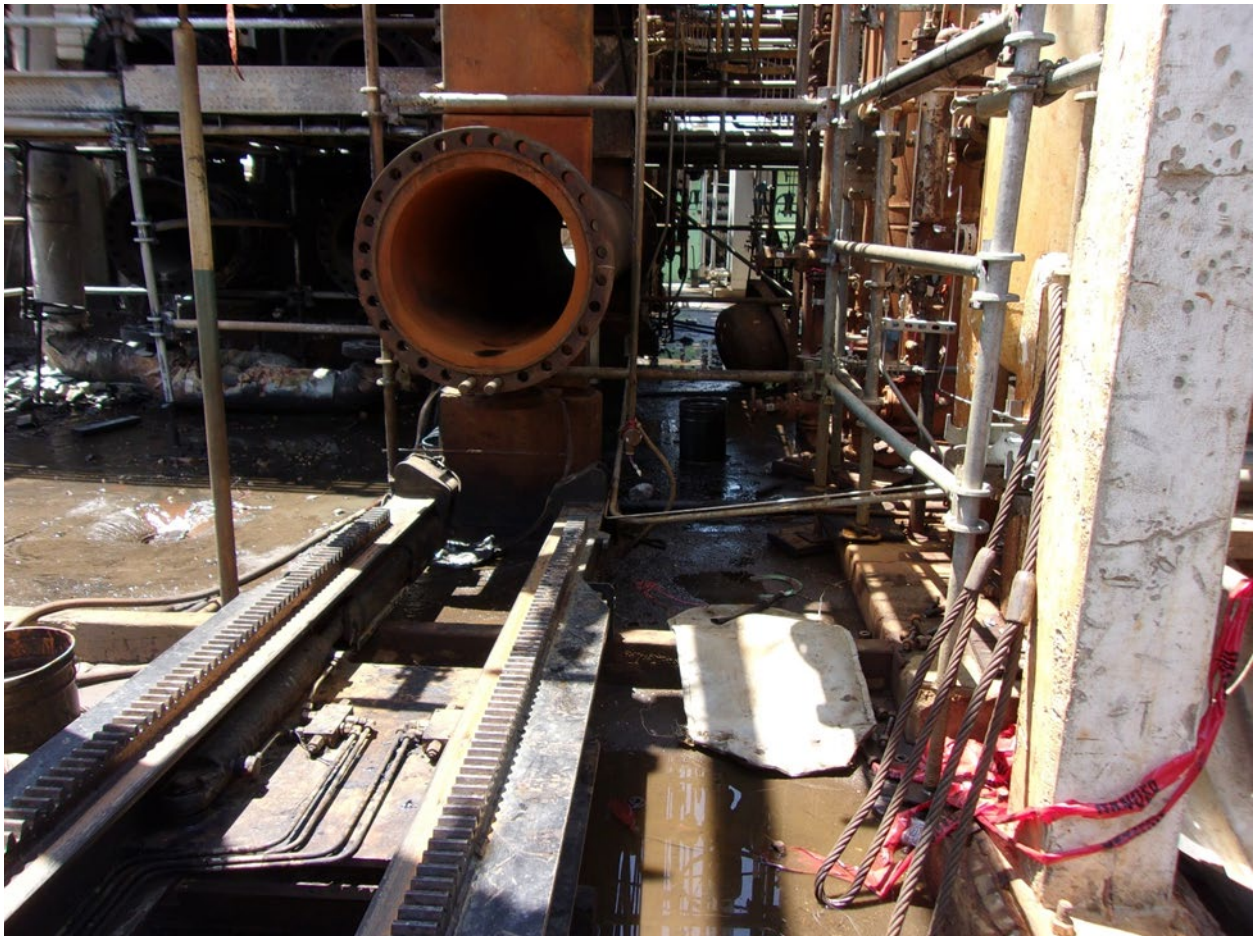
Following reports of the sparking seen on the night shift, the Maintenance Supervisor cordoned off an area approximately 8 feet by 5 feet around the broken conduit using red safety tape at 4:30 am July 19, 2018. This clearly delineated an area where access was prohibited due to a personnel safety issue. The tape was still in place when the day shift Maintenance Supervisor was shown the broken conduit around 5:50 am. However, an unknown person(s) removed the tape and contractors proceeded to work in the area, including installing the cleaned tube bundles in the HP Effluent Cooler Exchangers (3530.09 and 3530.10). The Investigation Team speculated that this may have been due to a self-imposed pressure by a contractor to meet their schedule, but there was no evidence available to support this. A witness stated that the tape had already been removed when they visited the area about 7:00 to 7:30 am July 19. Remnants of the red tape can be seen in Figure 6.

Figure 6. Remnants of Safety Cordon
